VIBRATION LABORATORY<http://www.kdi.tw><http://www.vibration.com.tw>E-mail: service@kdi.tw**TESTING / INSPECTION REPORT**

REPORT NO : VT-180417-1

SPECIMEN : TWP1560-IMX6 series

TEST / INSPECTION ITEMS : Vibration Test

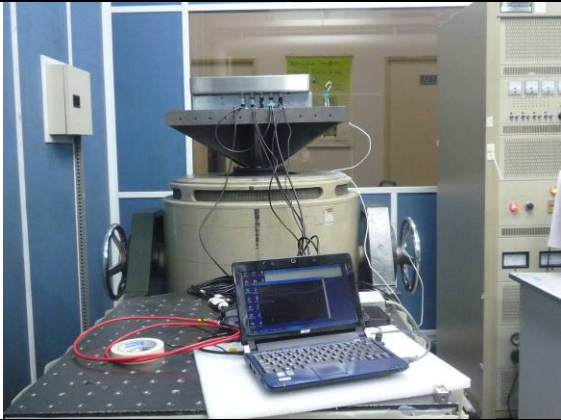
Vibration testing photos	
Testing equipment	Z axis

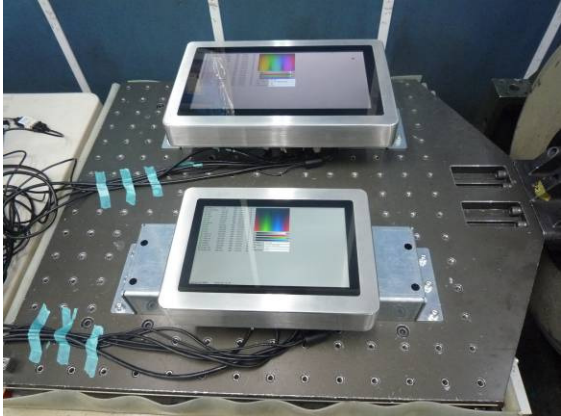
X axis	Y axis

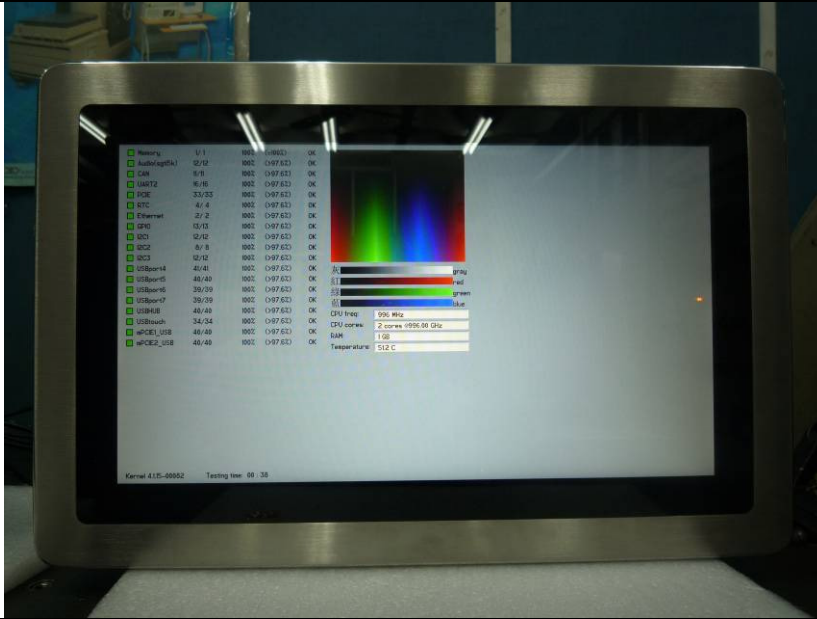
Testing photos
After test-1

Describe	PASS	FAIL	Non-Judgment
Function judgment	√	---	---
Appearance check	√	---	---
