VIBRATION LABORATORY<http://www.kdi.tw><http://www.vibration.com.tw>E-mail: service@kdi.tw**TESTING / INSPECTION REPORT**

REPORT NO : ST-180417-1

SPECIMEN : TWP1560-IMX6 series

TEST / INSPECTION ITEMS : Shock Test

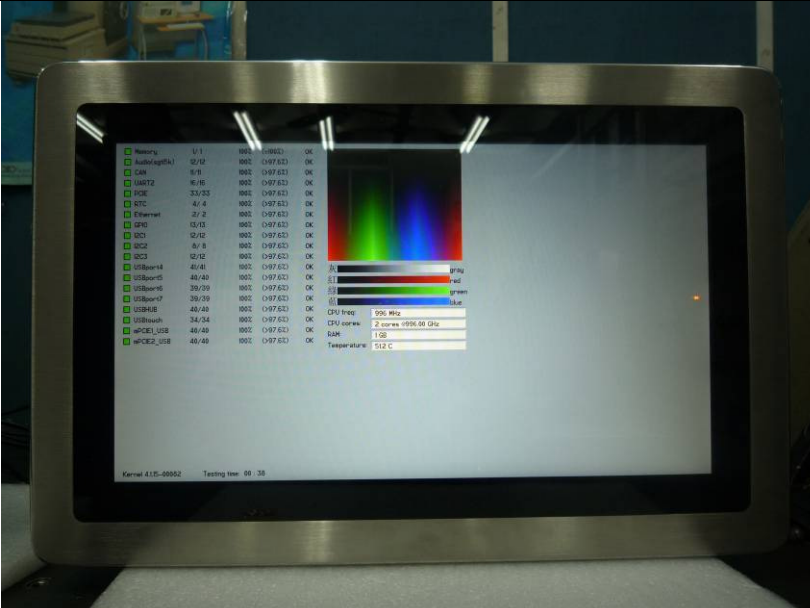
After test-1

Describe	PASS	FAIL	Non-Judgment
Function judgment	√	---	---
Appearance check	√	---	---
